All in one Solenoid Used on
E & F models of Bobkarts.
12 volt Cole Hersey 24450

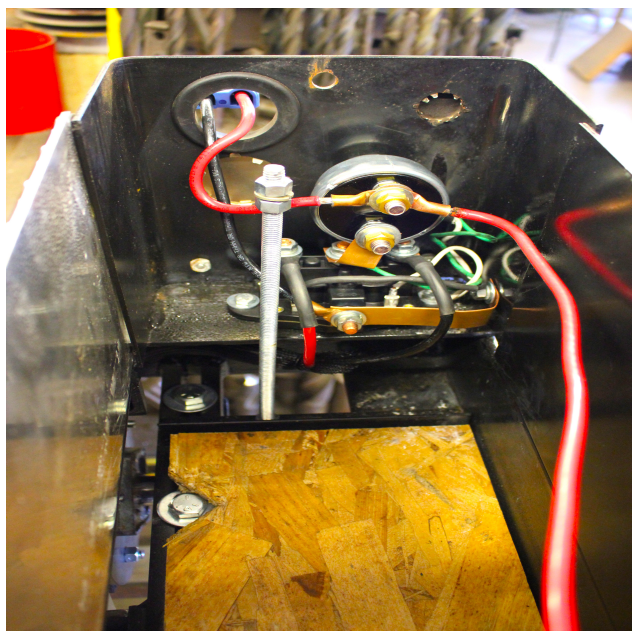
Wiring in Bobkart box, E & F models

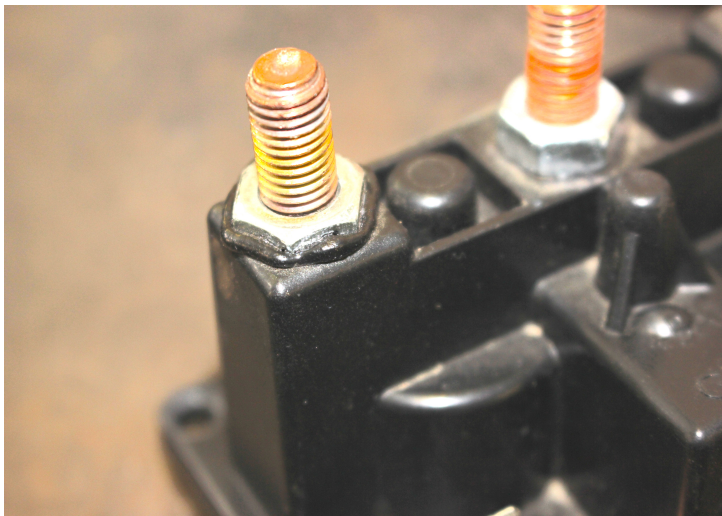
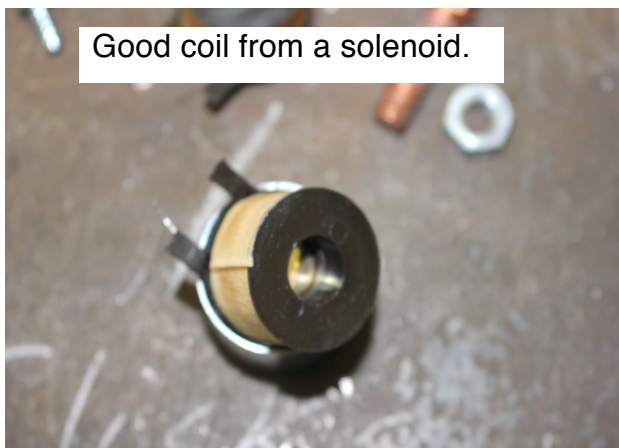
Melting around nut of stud indicates that the load side was shorted or overloaded for a long period of time.

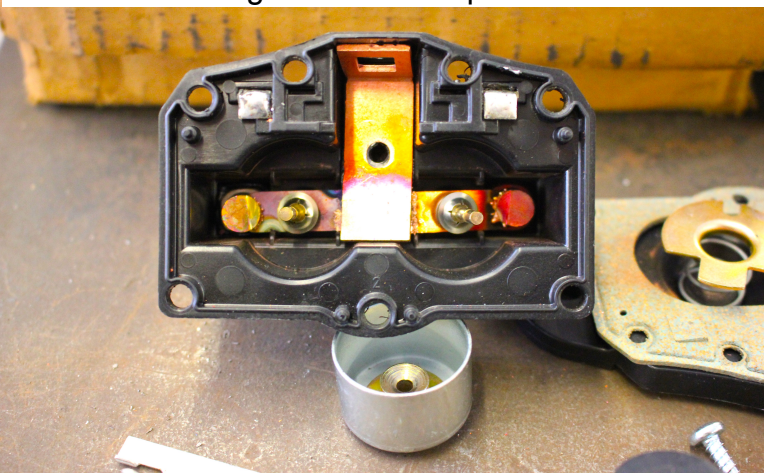
Inside the overloaded solenoid shows how the contact plate lost it's spring from over-heat and the contact on the right is arced inoperative.

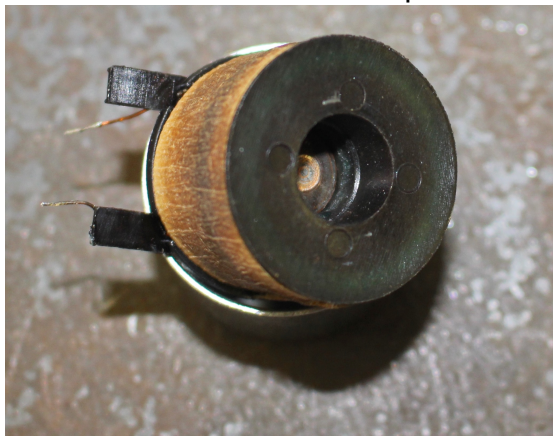
This solenoid was melted internally from 24 volts being sent through it, caused by two 12 volt batteries being wired in series instead of parallel.
